Macquarie Point Development Corporation

# Macquarie Point Stadium Development Geotechnical Interpretive Report

July 2024

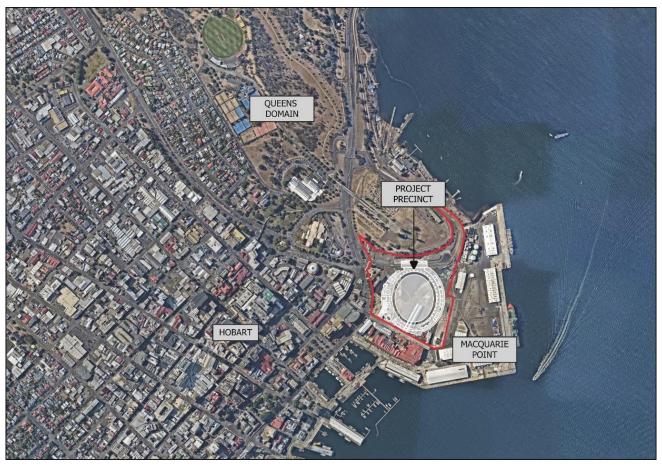
Figure 1.1 Project location

Macquarie Point lies to the north of Sullivans Cove, adjacent to the Hobart City Centre as shown in Figure 1.1. The precinct is approximately 9.3 hectares in size and is bounded by Davey Street to the West, Evans Street to the south, Hunter Street and the ports facility to the east, and the Hobart Cenotaph and Royal Hobart Regatta grounds to the north. The channelised Hobart Rivulet lies to the west and north, crossing the precinct near the northern boundary extent, where it flows into the Derwent River.

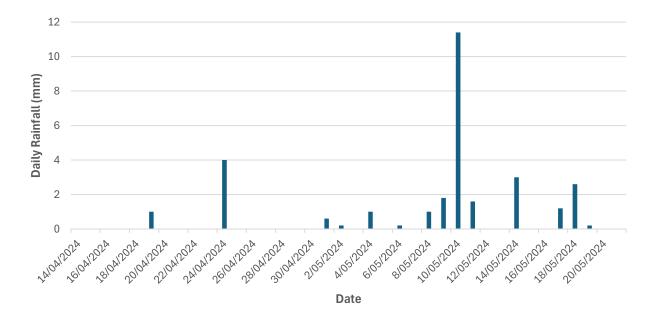
Daily rainfall totals during the site investigation are plotted below (Figure 2.3). The rainfall conditions around the time of the site investigation may impact groundwater levels measured during the works.

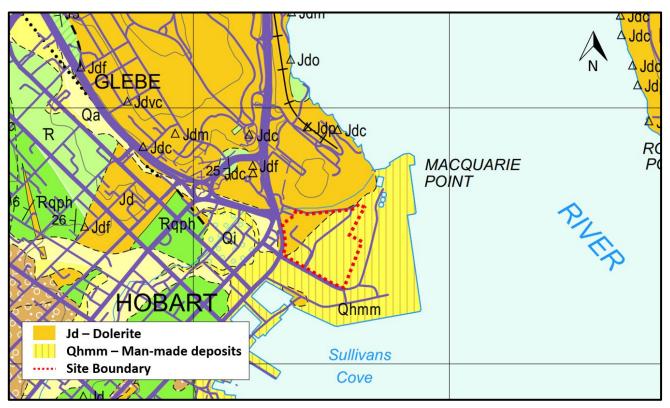
Figure 3.1 Macquarie Point Site Geological Map 1:25000 (Mineral Resources Tasmania)

At Macquarie Point, the Hobart Rivulet and the Park Street Rivulet have formed and eroded the bedrock on the alignment of faulting in the northwest-to-southeast direction, which generally parallels the southern boundary of the Queens Domain and Brooker Avenue. The water flow over many years has preferentially eroded the more highly weathered rock associated with the fractured zones along the fault alignment. Figure 3.1 provides an extract from the Hobart Geological Series Map, indicating general fault alignment responsible for the geological and geomorphological development of the rock strata underlying the Macquarie Point site.

After the last postglacial marine transgression [20,000–6,000 years ago; Harvey and Caton (2010)], the sea levels rose to fill these rift valleys with more recent Estuarine materials. These Estuarine deposits have formed interbedded sequences with the Alluvium from the smaller tributaries of the Derwent River and overly the bedrock. Fill placement has occurred since European settlement as part of the reclamation of Sullivans Cove, including Macquarie Point, the basins, and wharves on the west side of Sullivan's Cove and New Wharf (Salamanca) on the south side of Sullivan's Cove.

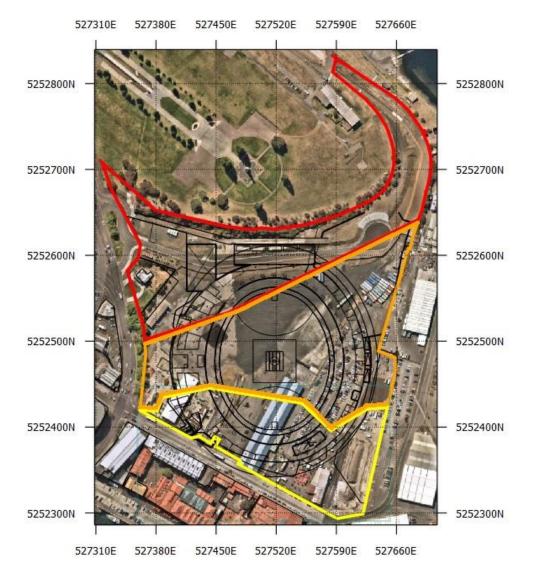
The site is characterised by 3 zones - the Northern, Central, and Southern - as shown in Figure 5.1.

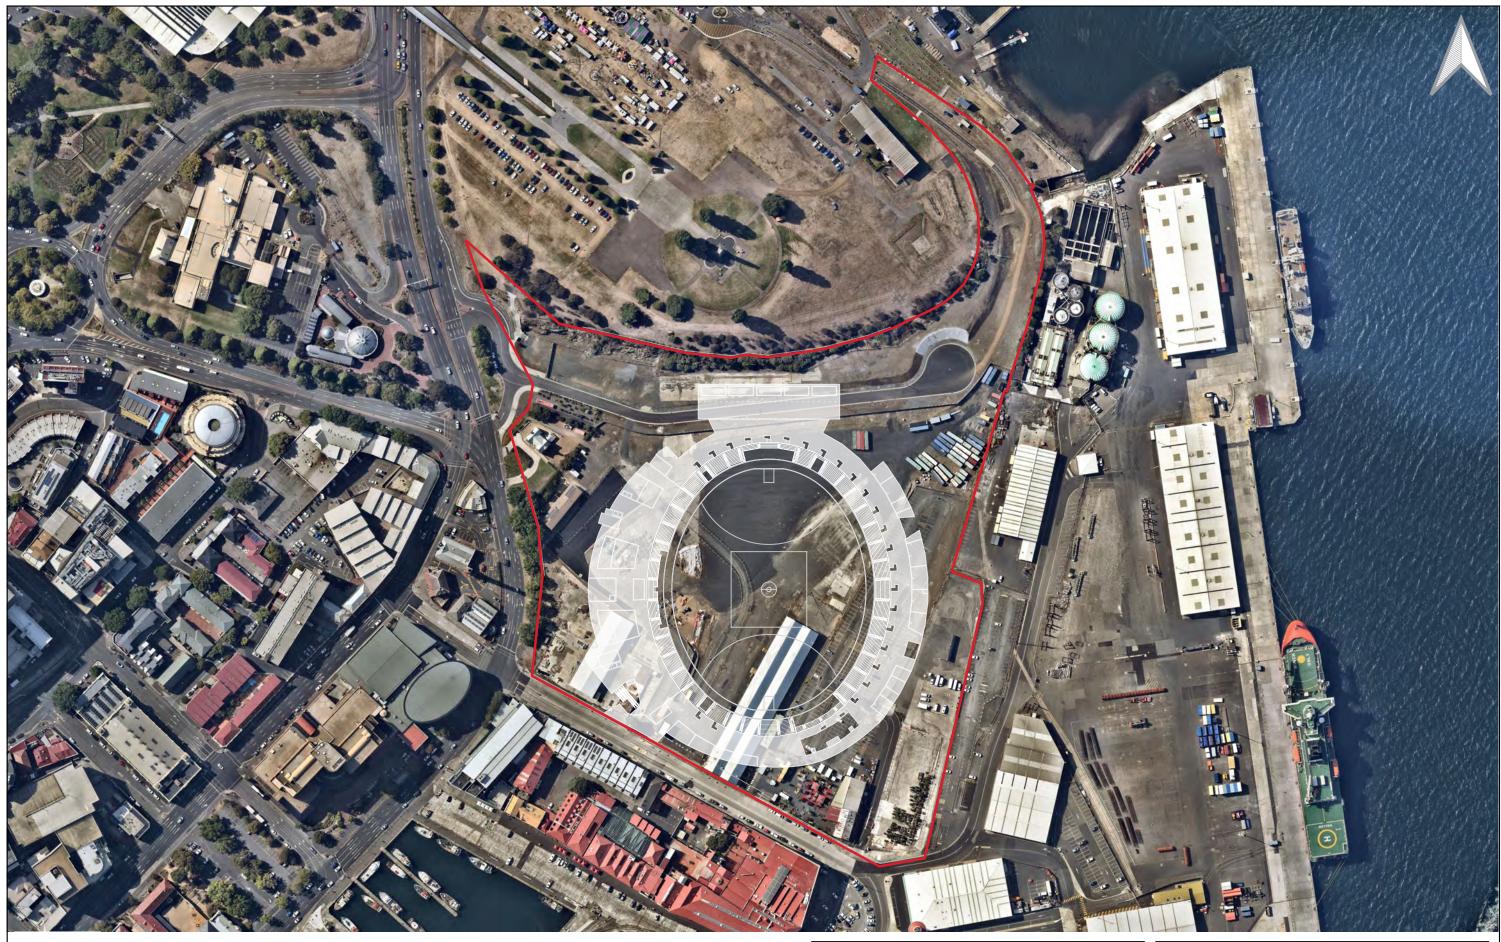
PROJECT NO	REV.	FIGURE
PS212776	0	A1

### TITLE Regional Site Plan

----- Site Boundary

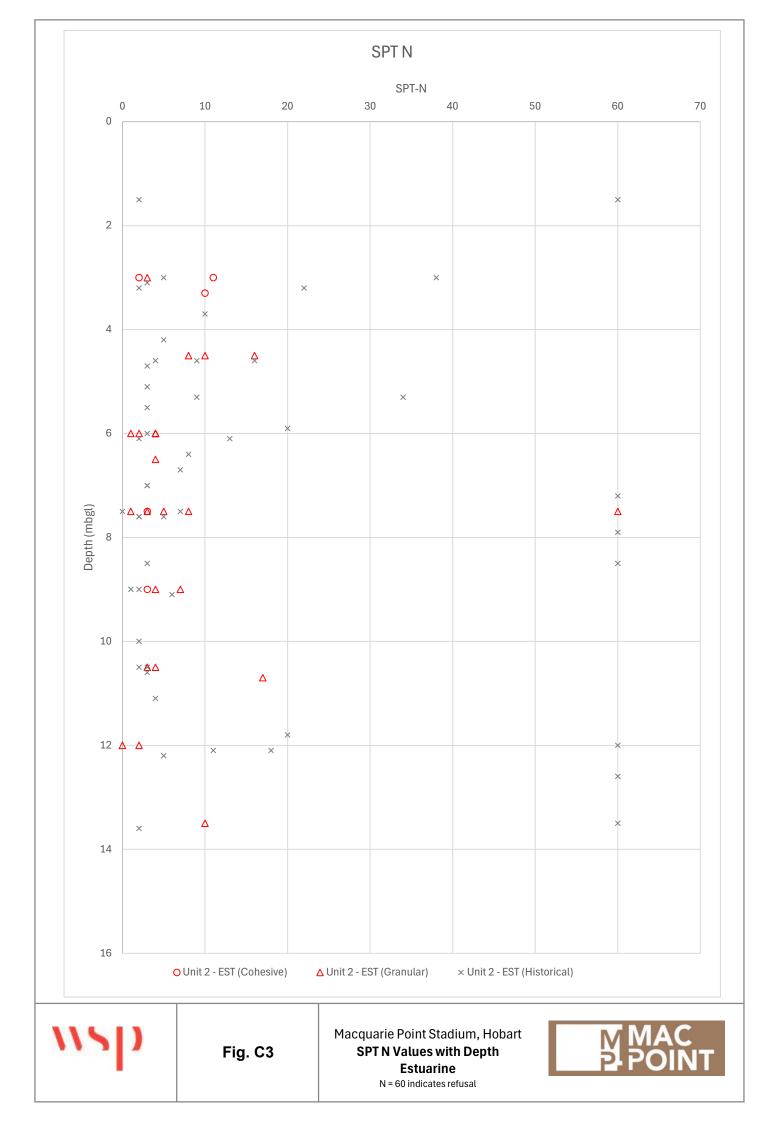
Fig	Title
C1	SPT N Value vs Elevation (All Lithologies)
C2	SPT N Value vs Elevation for Fill
C3	SPT N Value vs Elevation for Estuarine
C4	SPT N Value vs Elevation for Alluvium

SPT values generally range from N=0 to 60, with a median value of 4. The interquartile range is N =3 to 9 when omitting refusal values. Table 5.4 summarises the SPT N values obtained for the Estuarine deposit from historical and recent investigations. Refusal values were excluded due to potential cobble or boulder sized obstructions, which may not be representative of the material in general. Based on the median SPT N values, the relative density can be interpreted as very loose to loose. The SPT plots are presented in Figure C3 (Appendix C).

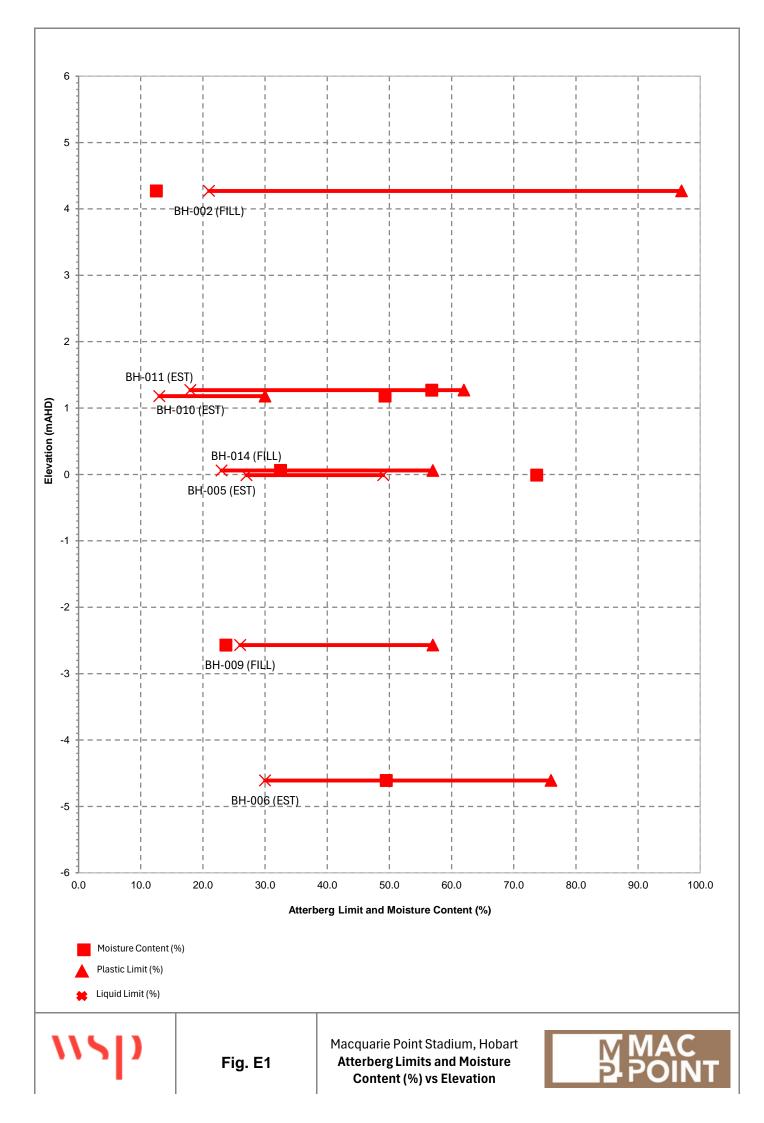
Fig	Title
E1	Atterberg Limits and Moisture Content vs depth
E2	Plasticity Chart
E3	Particle Size Distribution – All Units
E4	Particle Size Distribution – Fill
E5	Particle Size Distribution – Estuarine
E6	Particle Size Distribution – Alluvium
E7	UCS vs PLT Axial
E8	UCS / PLT Axial / PLT Diametral
E9	RQD bands by Weathering

Eight (8) moisture content tests were scheduled at depths between 0.1 m BGL and 6.8 m BGL. The moisture content values range from 12.5% and 56.8% with a median of 32.2%. Figure E1 (Appendix E) provides the Atterberg limits and Moisture Content vs depth.
